**DATE: 02/22/2021**

**INVESTIGATOR: Neal Heil**

**STOP 1 – HIGHWAY 66 WEST of  
ASHLAND GUN CLUB**

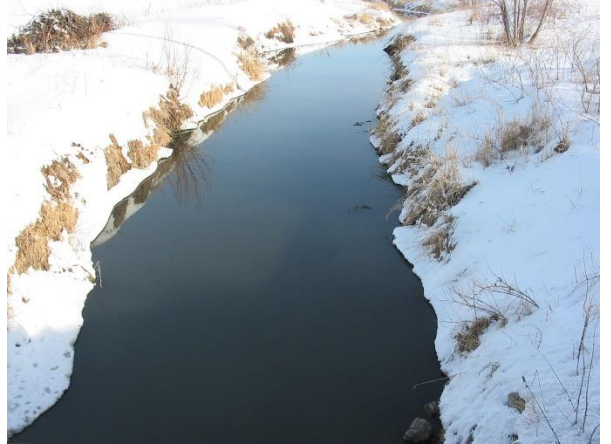
Water/liquid present. No unusual odors noted.

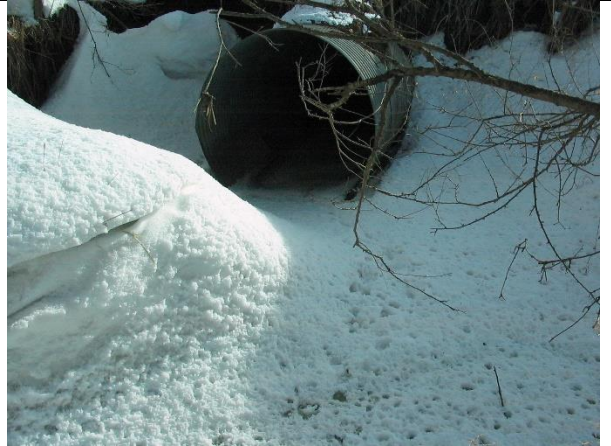
**STOP 2 – North of the Intersection of  
COUNTY ROADS 6 & F**

Fresh snowfall and ice observed upstream from culvert. No flow observed entering culvert. No flow observed leaving downstream opening of culvert.

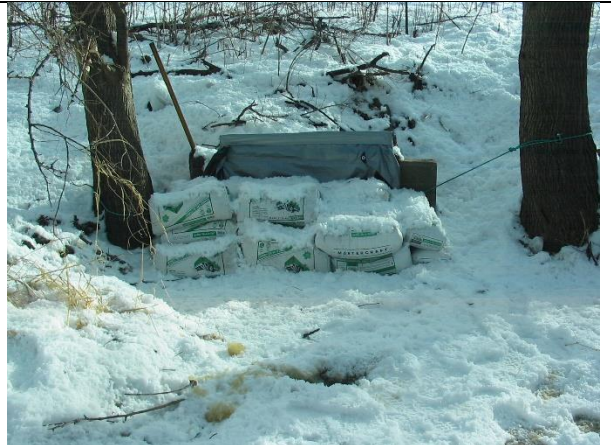
**STOP 3 – Road 7/Highway 66**

Sandbags rearranged since my previous visit and blue nylon rope leading into entrance to culvert. Brownish liquid observed in hole chopped into ice prior to my visit. Called Brad Pracheil to advise liquid presumed to be spilled material present at this location.

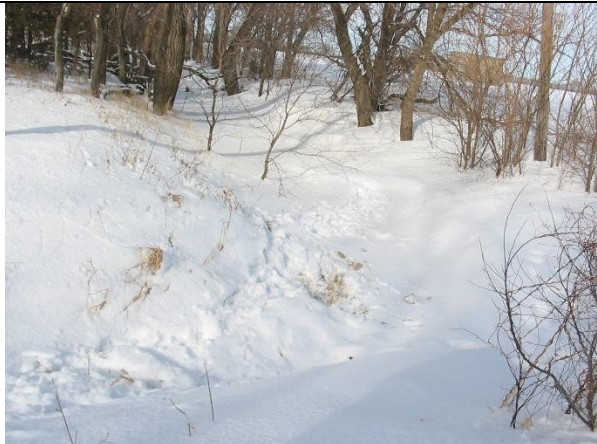
<p><b><u>STOP 4 – County Road 8, North of Road H</u></b></p> <p>Brownish-colored ice present below fresh layer of snow; same as previous visit.</p>

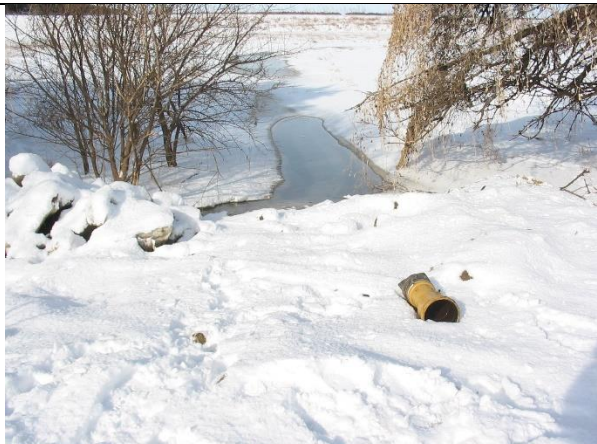
<p><b><u>STOP 5 – UN-L Eastern Extension – North of County Roads 9 &amp; J</u></b></p> <p>Liquid observed upstream of road. Downstream snow-covered. Generator present, but not running. Hoses present, but not connected to anything.</p>

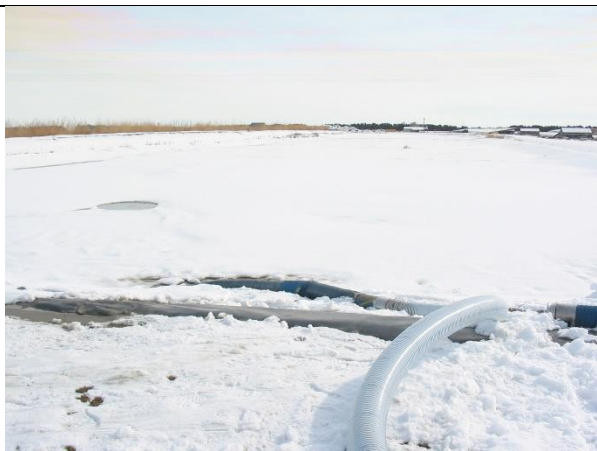
<p><b><u>STOP 6 – ALTEN LLC FACILITY DIGESTERS</u></b></p> <p>Truck with “Bucklin” on door and three workers present at south digester. Using gasoline-powered pump to pump from digester piping vault to lagoon immediately east of south digester. Lagoon contains liquid within 5-10 feet of top of berm. I was told no flow out of south digester. North digester as before (no observed leaks). Several workers using hose emitting steam to melt large ice structure on south side of north digester.</p>

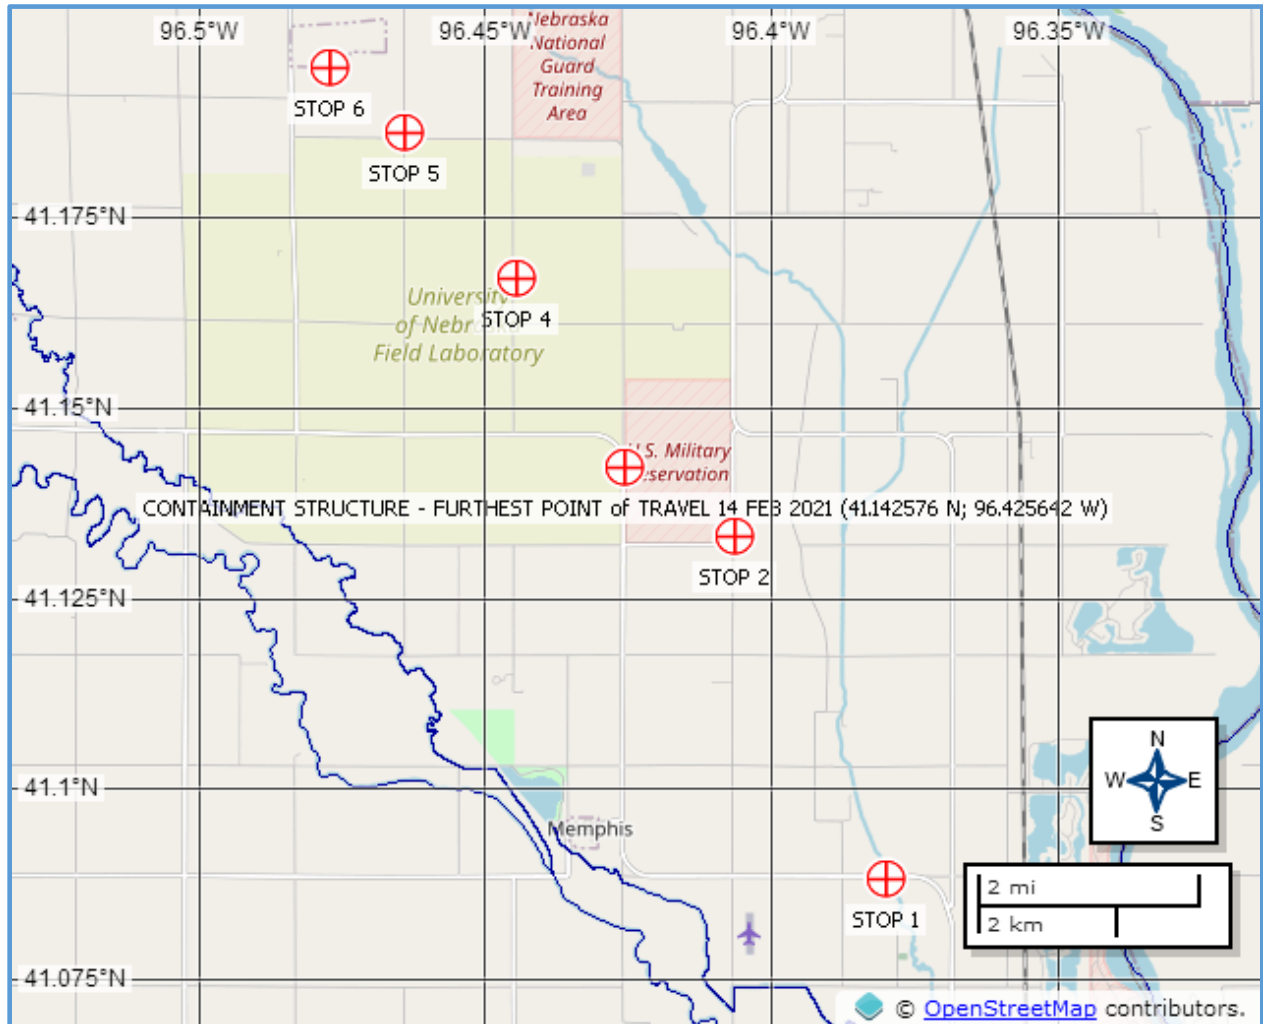
command center. No vehicles with Clean Harbors marking observed on property. No cleanup activity observed with the exception of pump connecting south digester to lagoon to the east and ice structure on north digester being melted with steam. I met Terracon representative James Koehler at Stops #1 and #2.
